# **Rucks Bridge & Eysey Lock Project**

This document outlines the work needed on both structures and outlines the way that they might be achieved.

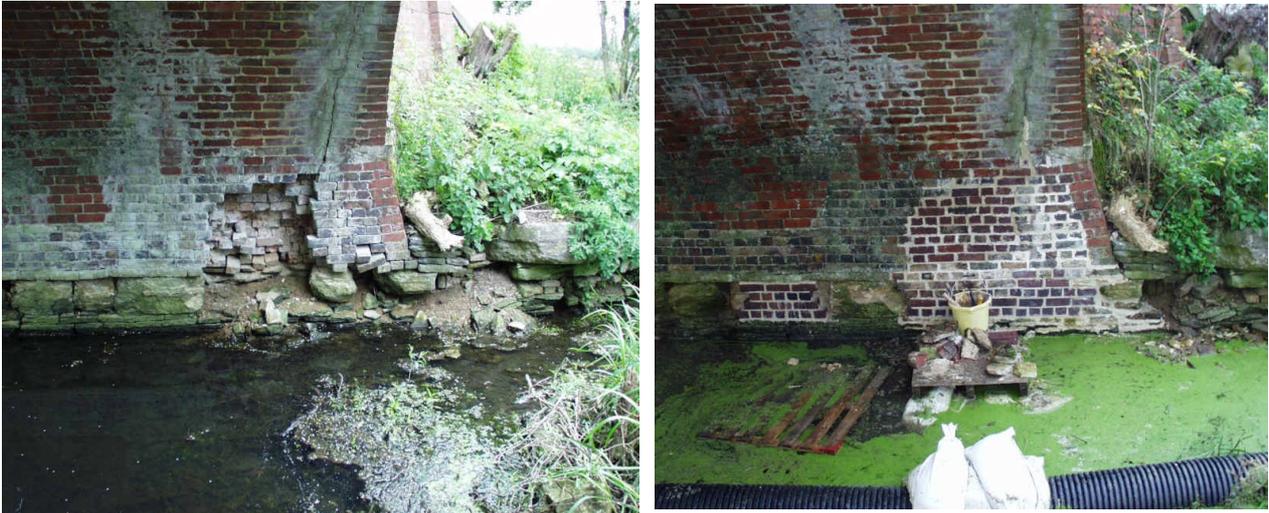
Rucks Bridge is an ongoing restoration project which started in 2006. The initial works have mainly been aimed at repairs to the offside (north) lower abutment which was becoming compromised due to the disintegration of a row of stones at what was the original waterline. Some of these had broken up and sections of the brick wall above had collapsed due to lack of support. The damaged section of stonework are being replaced by hard engineering bricks following advice from British Waterways.

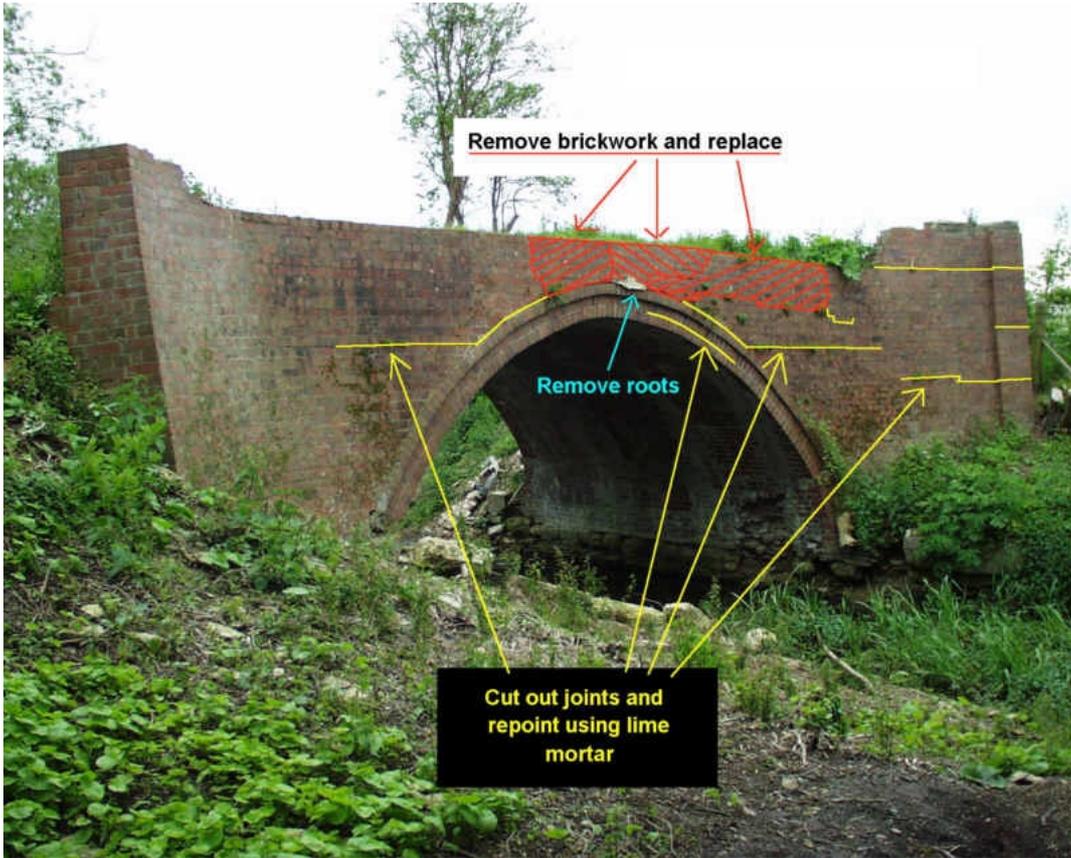
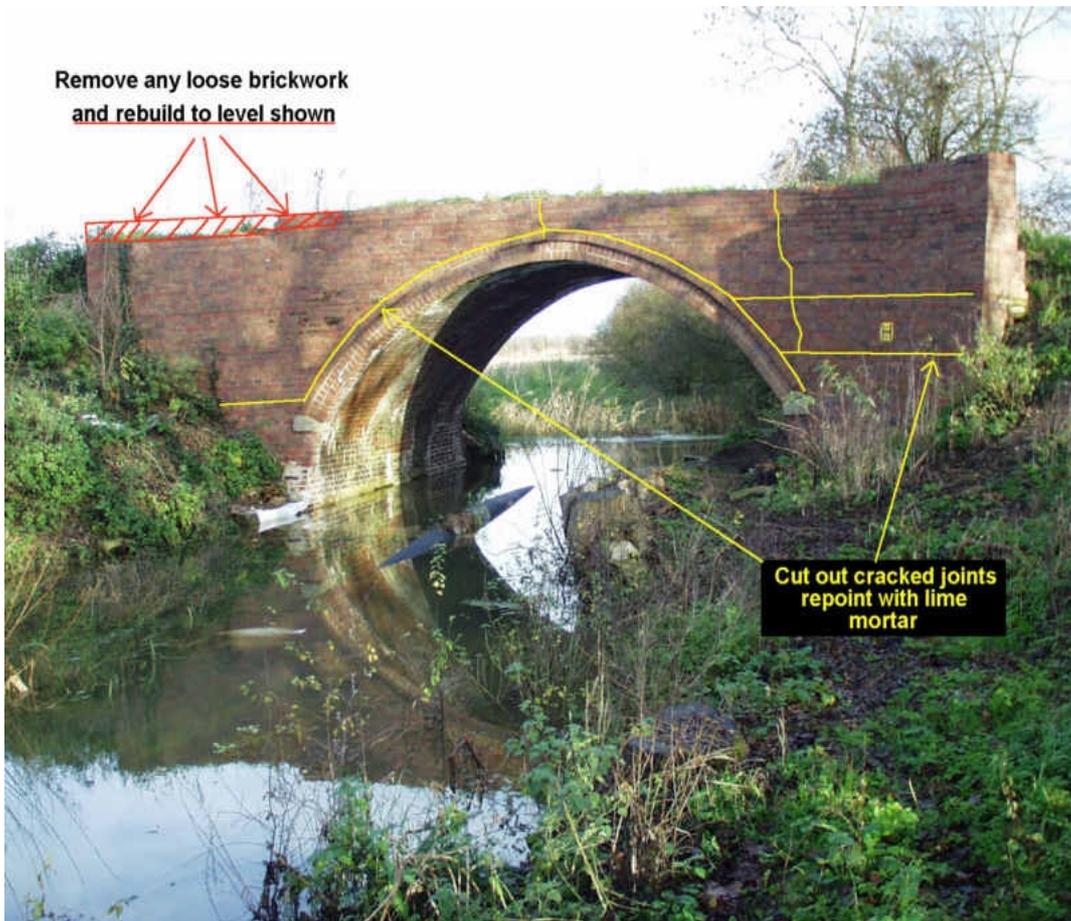
- 1) Completion of the repair work to the offside abutment wall
- 2) Removals of large stumps and roots from towpath wall
- 3) Repair of the towpath wall in brick and dry stone walling to match original
- 4) Repair of the offside approach walls
- 5) Dismantling of upper brickwork displaced by root damage and root removal (east side)
- 6) Repair of upper brickwork (east side) using cleaned original bricks and portland cement
- 7) Removal and replacement of damaged upper courses (west side)
- 8) Cutting out and pointing of cracks caused by settlement of the bridge using lime mortar

Items 5 & 6 will require the erection of scaffolding on the east side of the bridge by suitable external contractors. Due to the costs, the duration the scaffolding needs to be in place wants to be kept to a minimum so this should go up just prior to the WRG summer camp and completion of these works should be prioritised.

Ideally this will be followed by excavating out the bridge hole and the repair of any defects in the lower towpath wall and abutments.

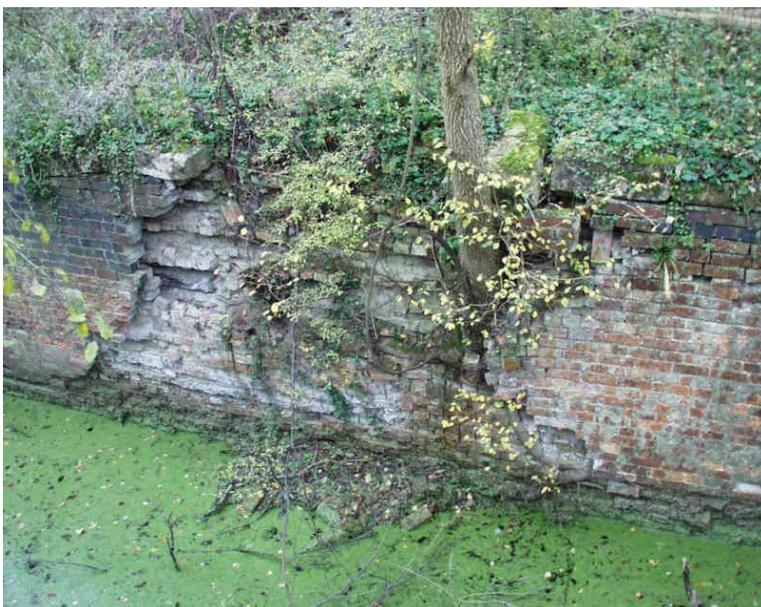
The canal above the lock is dry with minimal silt and access to work on the top sill area is good.

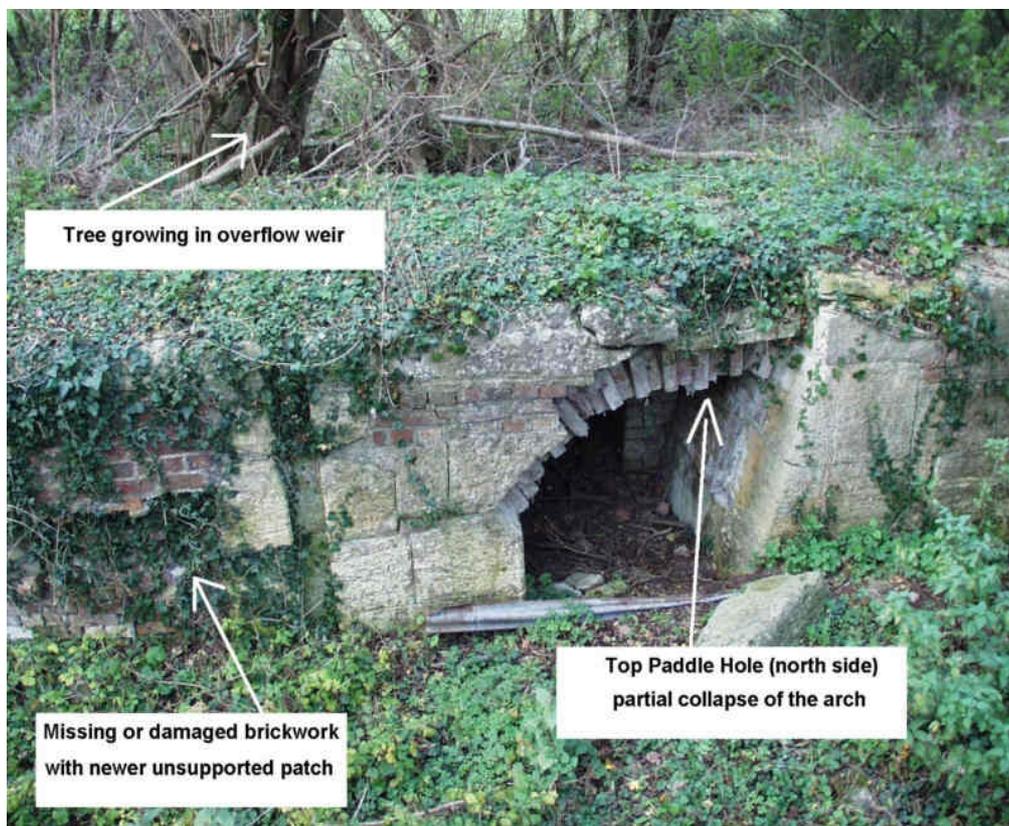
Both of the top paddle arches have partially collapsed at the face. The overflow weir appears to be in better a condition than most with the crest stones in place. The condition of the outflow culvert is unknown.

The aim will be to carry out repairs to the head walls, paddle holes, gate recesses and overflow weir which are accessible at the top end of the lock without clearing and draining the main chamber.

This is likely to involve the removal and replacement of areas damaged brickwork, repointing and the lifting and resetting of some of the coping stones. Work of this nature is best carried out in dry weather and when the temperature at night is unlikely to fall below about 5 C. Much of this work will employ lime mortar and there will be a need for a quantity of replacement bricks of the right size, colour and specification (Coleford Brick Company being the source used by BW). If not in stock, these will need to be ordered at least 3 months prior to delivery.

The top sill area will need to be cleared and surfaced in such a way as to prevent future vegetation damage.
